Navajo Abandoned Uranium Mine

Site Screen Report

East Mesa Mines AUM Site

March 2010

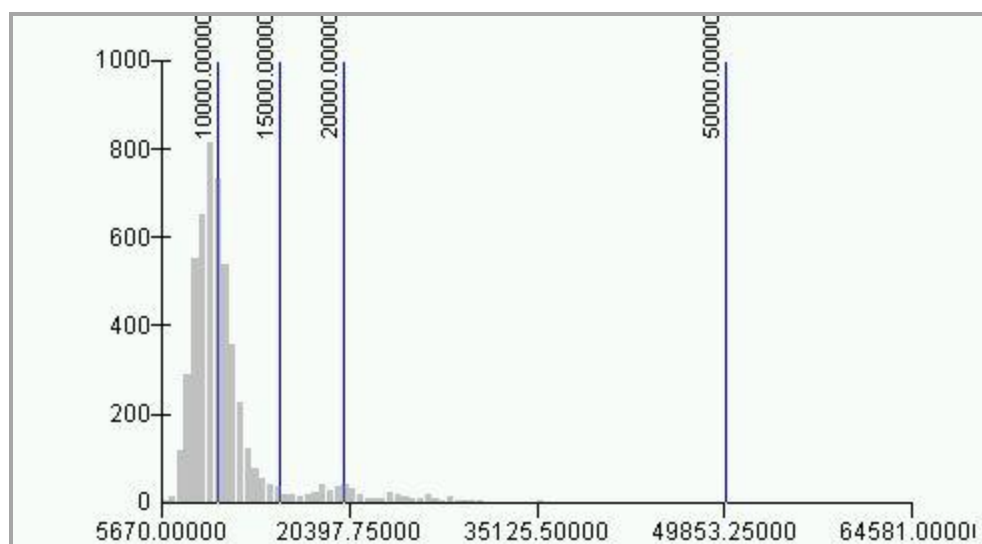
The following chart and statistics were generated by ESRI ArcGIS 9.3.1, and show the general distribution of the site gamma radiation measurements. The horizontal X axis represents the gamma radiation reading levels in cpm (lowest levels to the left). The vertical Y axis represents the frequency of each gamma radiation level.

Count:	5101
Minimum:	5670.00000
Maximum:	64581.00000
Sum:	56415362.00000
Mean:	11059.66712
Median:	9882.00000
Standard Deviation:	4712.10787

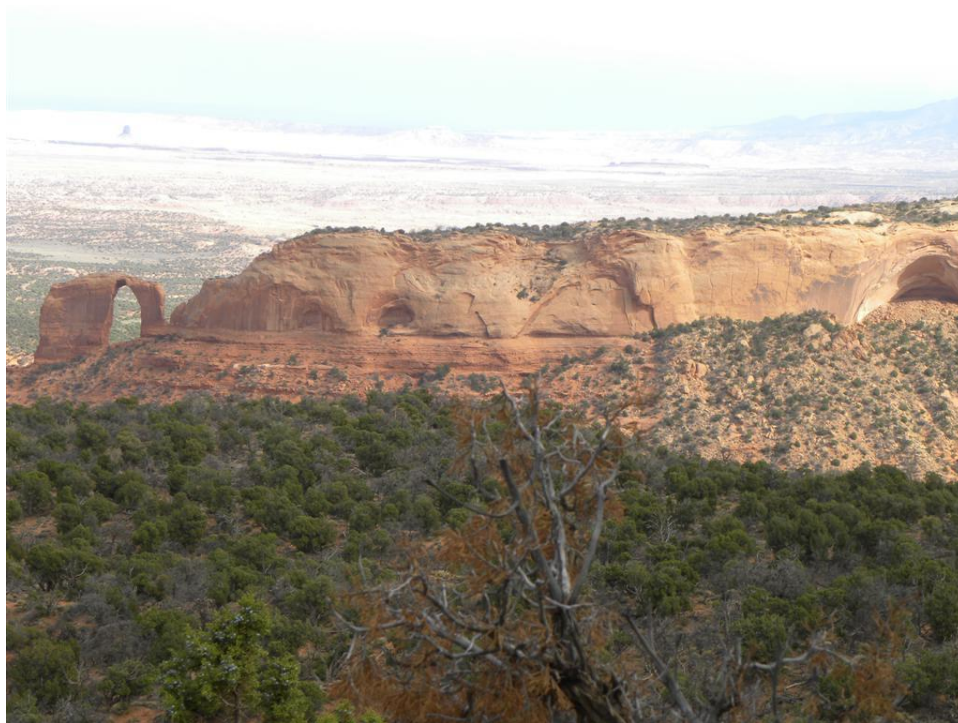
Photo 1. View from top of mine site

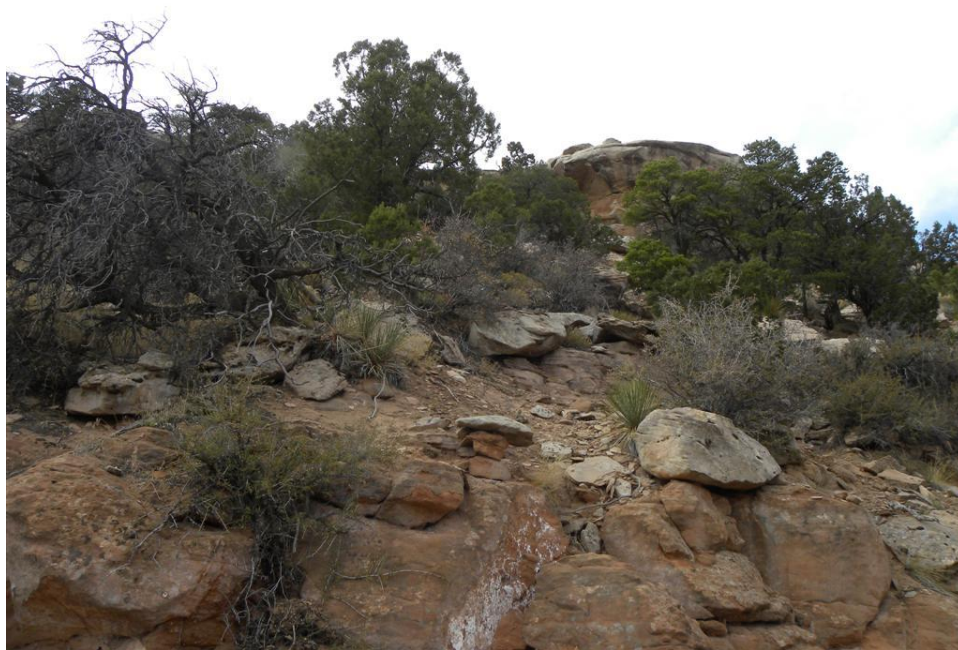
Waste debris below mine workings on cliffs, 600' x 75', with a total estimated volume of 8,333 yd³

Photo 2. Portion of waste debris pile

Unreclaimed waste pile

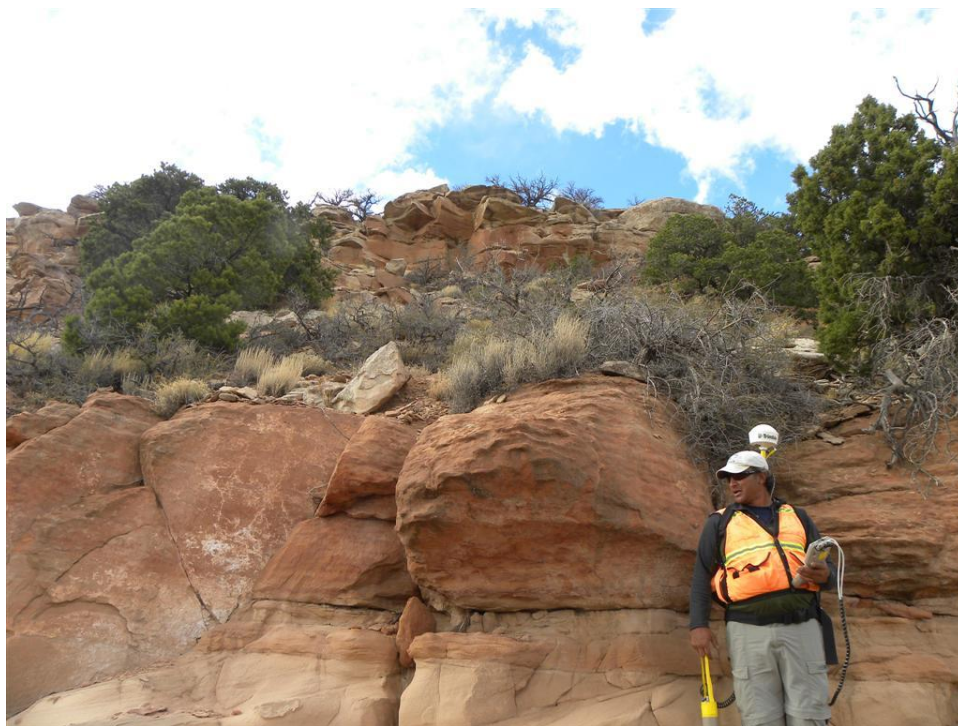
Photo 3. Below waste debris pile

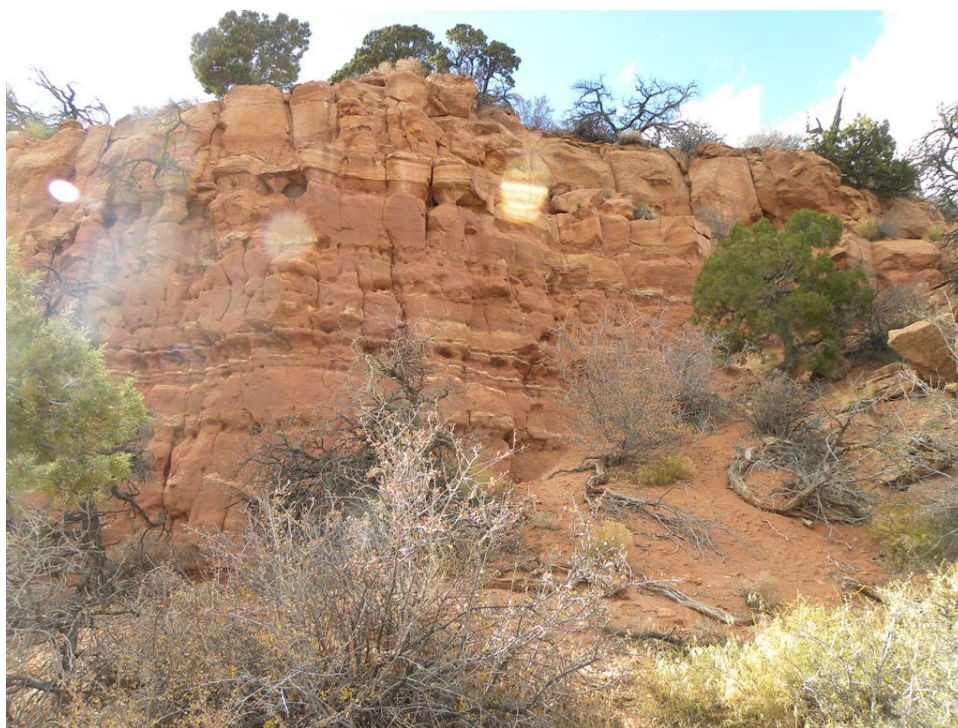
Photo 4. Cliff area

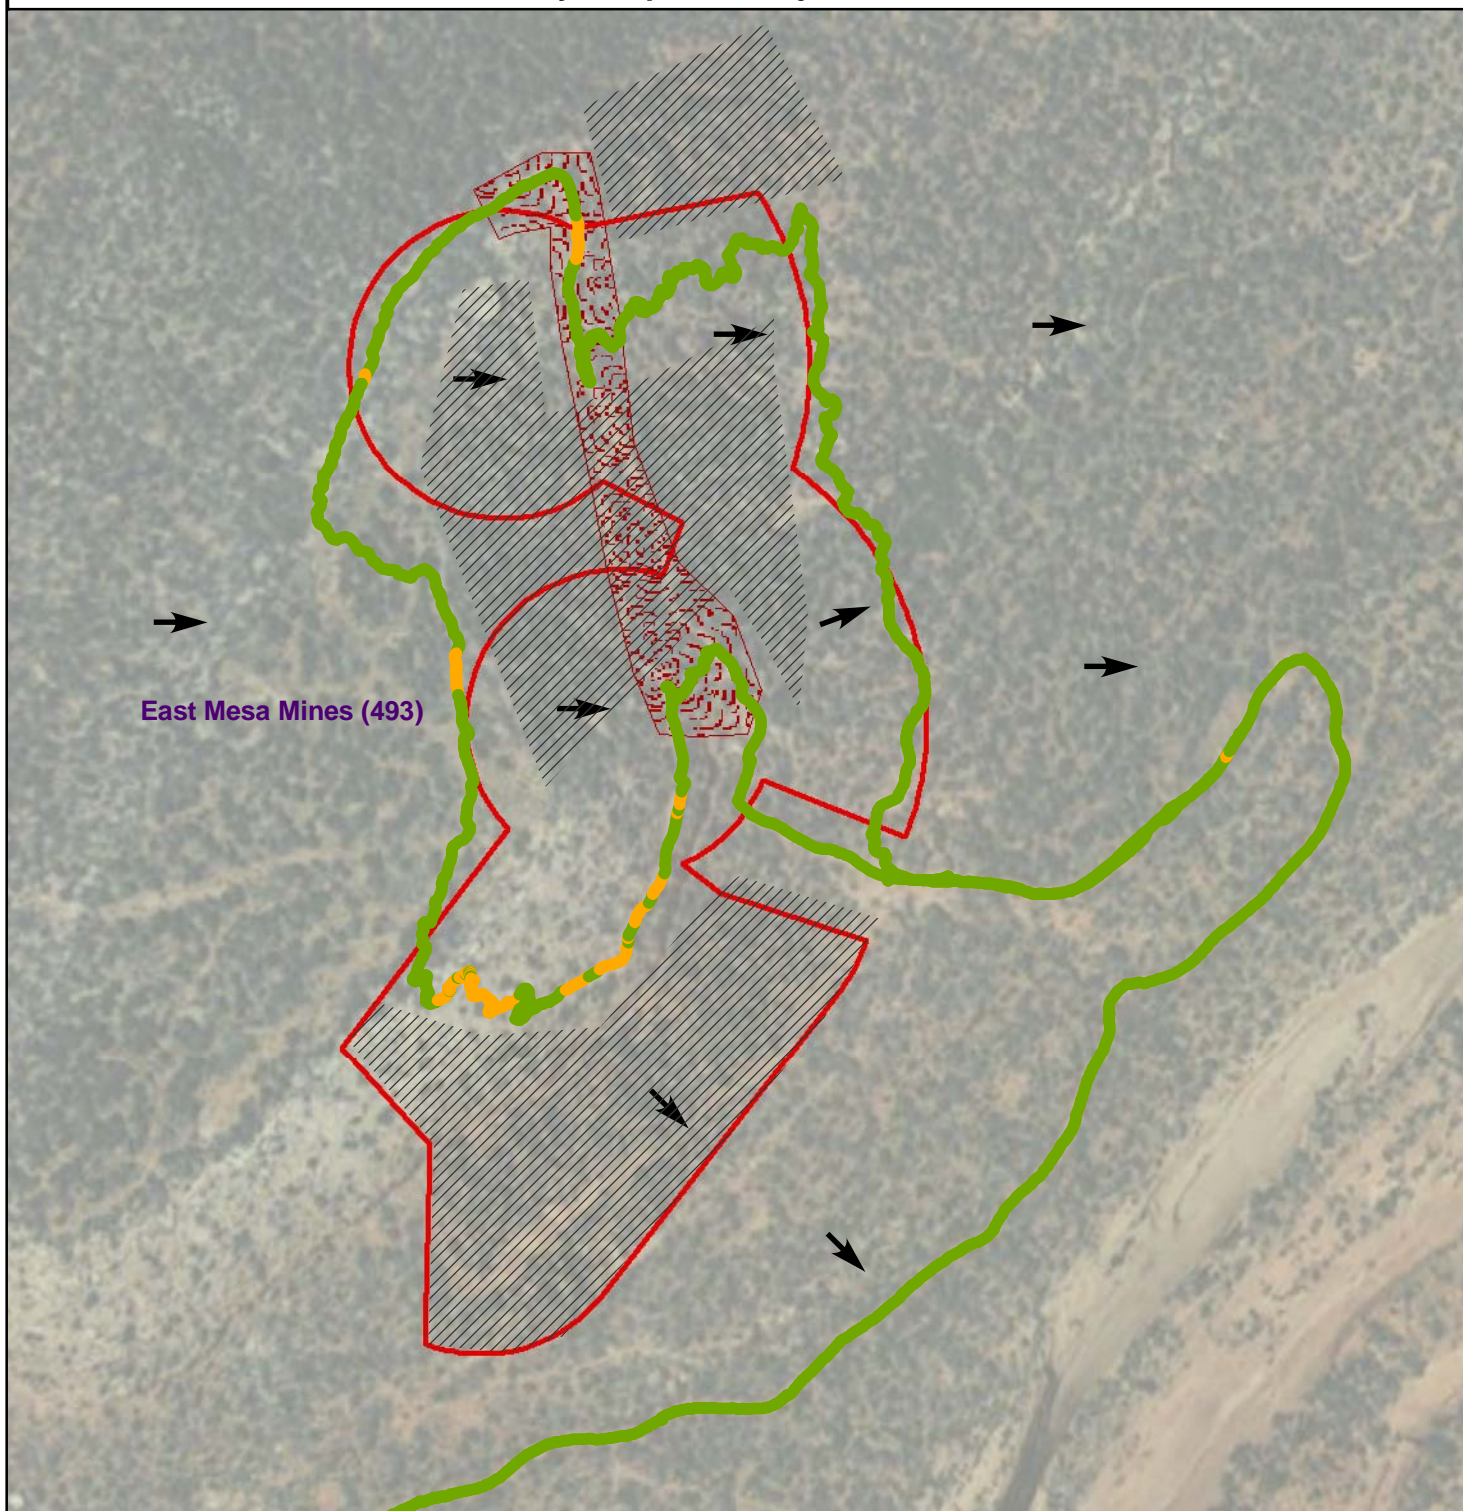
A total of 5,101 gamma radiation measurements were collected from the mine site, ranging from 5,670 cpm to 64,581 cpm. Measurements in the vicinity of the waste debris were found at levels up to 65,000 cpm. The measurements are represented in Figures 1 and 2.

**Figure 1 - Gamma Radiation Measurements, Above Two Times Background
East Mesa Mines (493)
Red Valley Chapter, Navajo Nation, Arizona**

Gamma survey conducted 10/2009
Measured as counts per minute (cpm)

Average background = 9,223 cpm

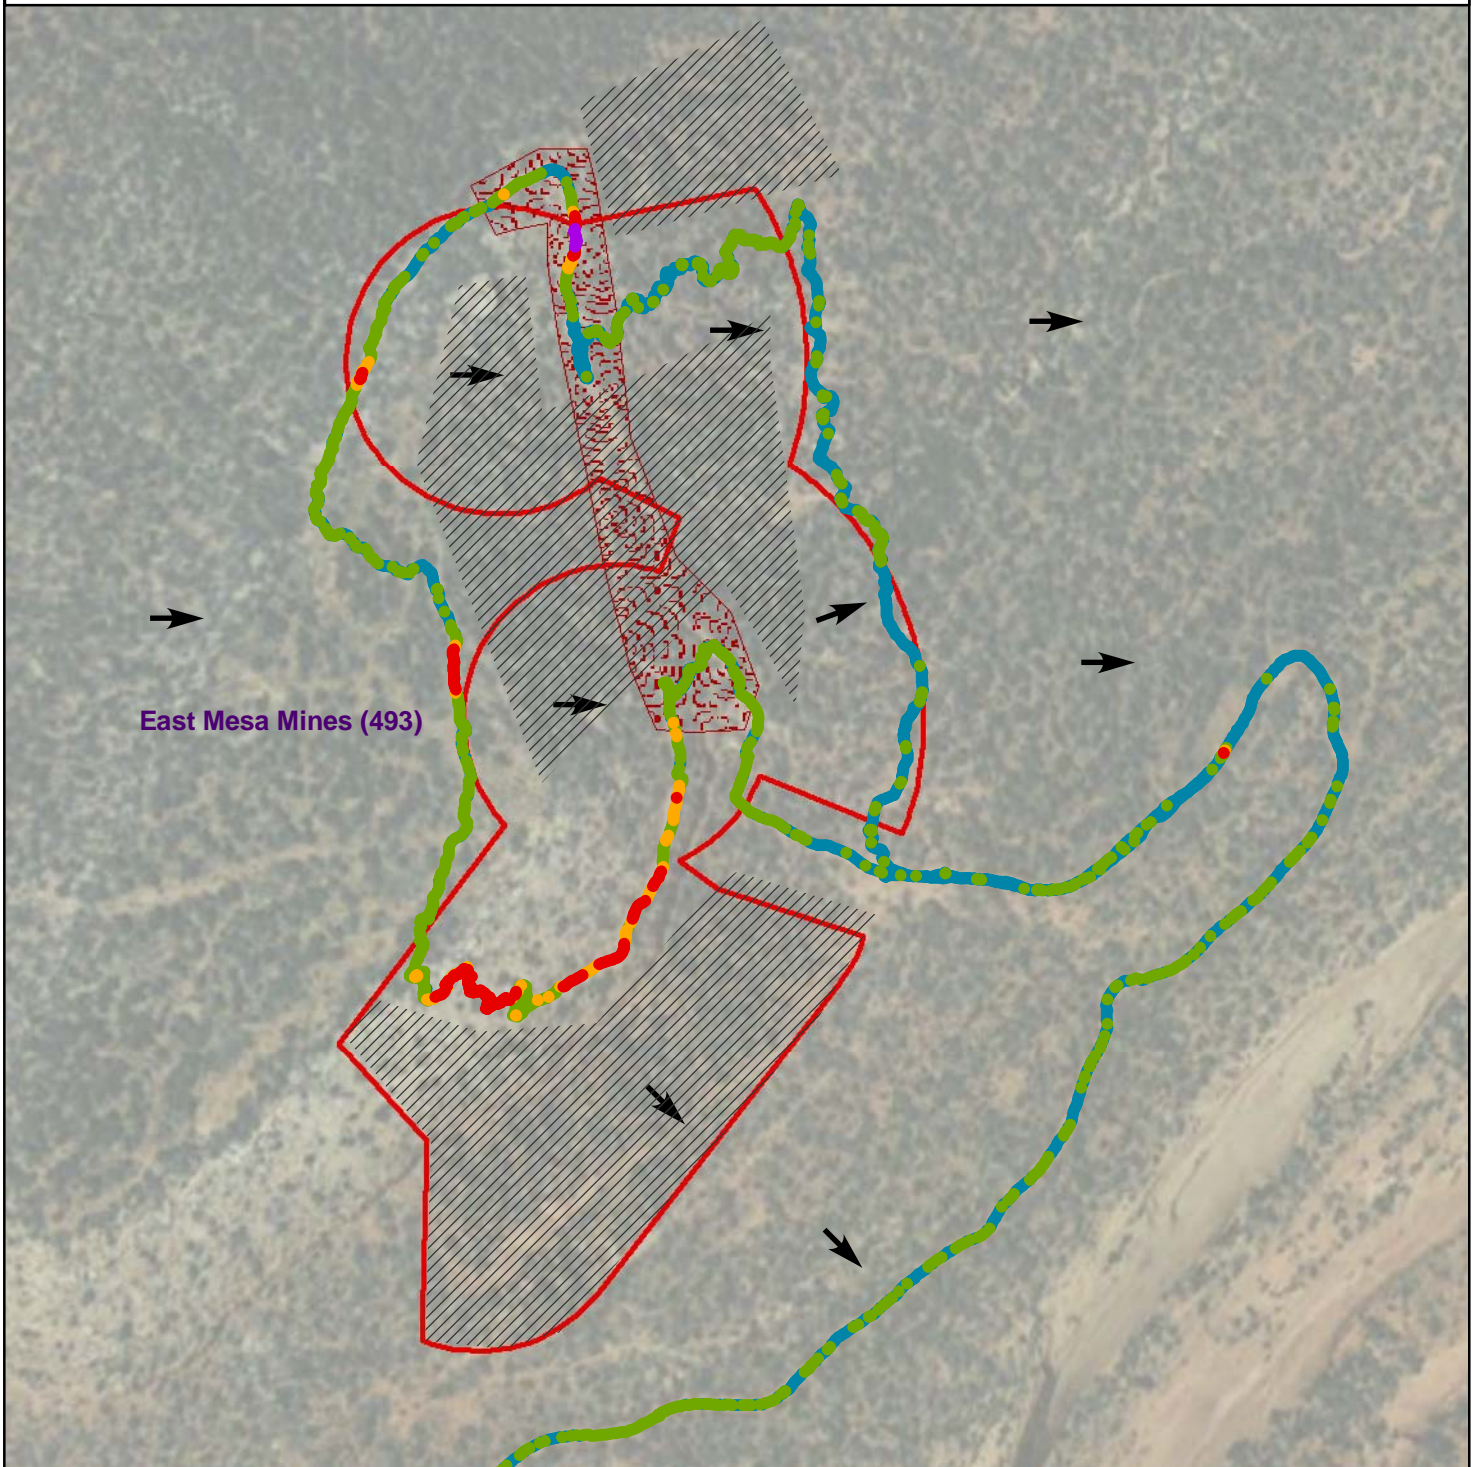
**Figure 2 - Gamma Radiation Measurements
East Mesa Mines (493)
Red Valley Chapter, Navajo Nation, Arizona**

**Gamma survey conducted 10/2009
Measured as counts per minute (cpm)**

Average background 9,223 cpm
